ALERT SERVICE BULLETIN

October 23, 2018

ASB273A

A-20028 IDLER GOVERNOR GEAR BEARING INSPECTION INSTRUCTIONS

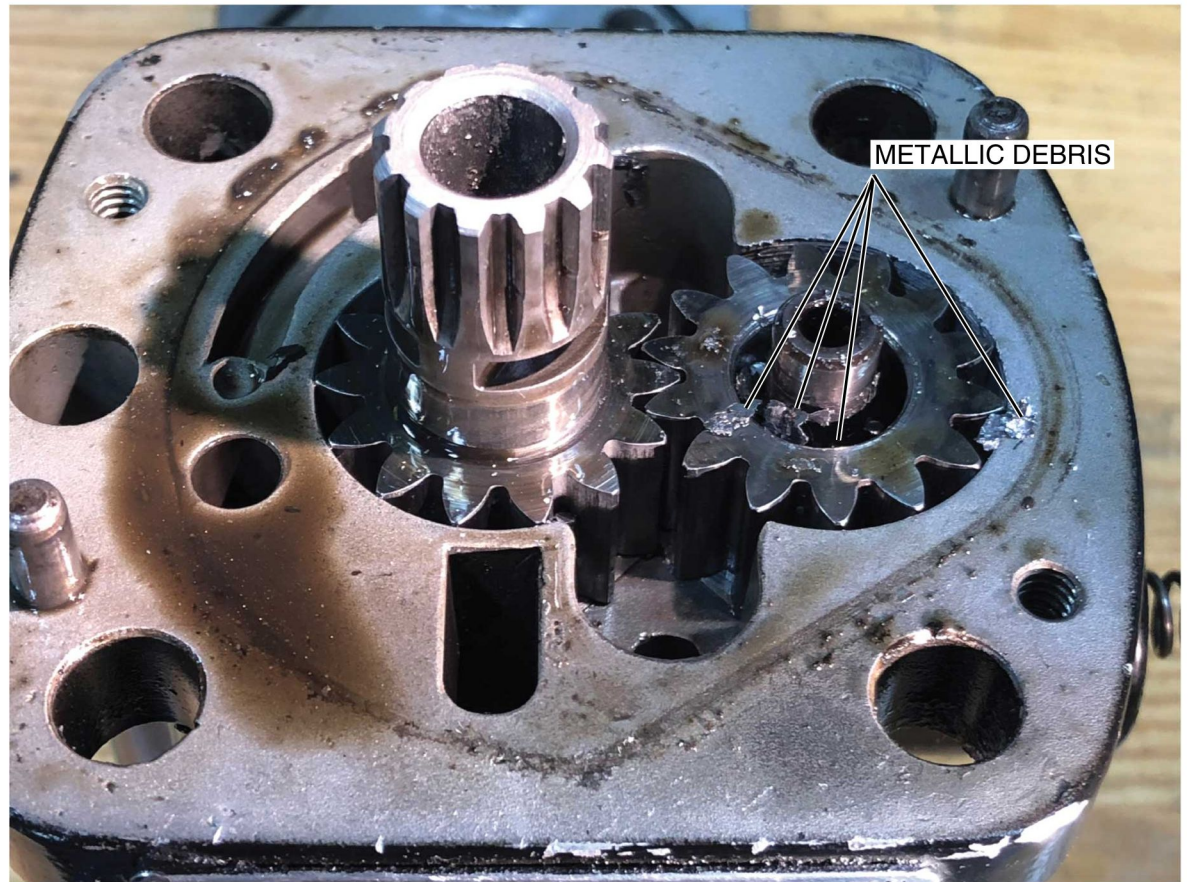
Figure 1. Metallic Debris Example (Sheet 1)

1. DO THE A-20028 IDLER GOVERNOR GEAR BEARING INSPECTION
 - A. Governor Evaluation, do the following:
 - (1) Remove the affected governor from the engine in accordance with the aircraft manufacturer or applicable STC holder's instructions.
 - (2) Remove the C-20943 cover-pump housing from the governor assembly. Examine the inside of the housing and the base of the exposed governor (Refer to Figure 1). Note and photo document any signs of metallic debris.

- (4) Remove the pressure relief plug and spring. Examine pressure relief port for signs of metallic debris.
 - (5) If signs of metallic debris were observed/noted in steps (2), (3), or (4), go to Section D.

- D. If Metallic Debris **WAS** Observed/Noted, refer to the McCauley Governor Manual 780401 and do the following:
- (1) Remove and retain the A-20107 idler gear assembly.

- (2) Overhaul the governor and complete associated actions as indicated in McCauley SB215C
- E. Stamp the letter "B" (Approximately 1/8th of an inch character) on the governor body as shown in Figure 2.
