# ALERT SERVICE BULLETIN

ASB273B

A-20028 IDLER GOVERNOR GEAR BEARING INSPECTION INSTRUCTIONS

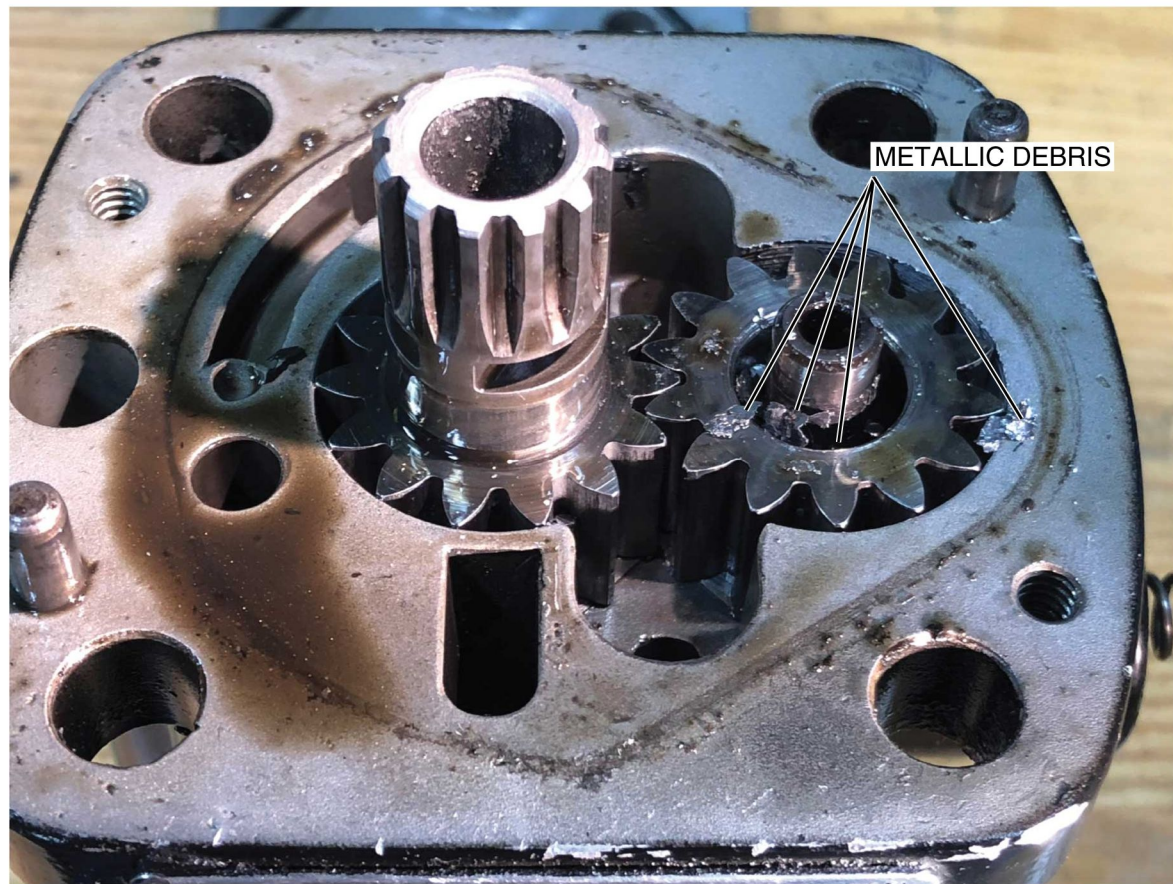
Figure 1. Metallic Debris Example (Sheet 1)

1. DO THE A-20028 IDLER GOVERNOR GEAR BEARING INSPECTION
  - A. Governor Evaluation, do the following:
    - (1) Remove the affected governor from the engine in accordance with the aircraft manufacturer or applicable STC holder's instructions.
    - (2) Remove the C-20943 cover-pump housing from the governor assembly. Examine the inside of the housing and the base of the exposed governor (Refer to Figure 1). Note and photo document any signs of metallic debris.

- (4) Remove the pressure relief plug and spring. Examine pressure relief port for signs of metallic debris.
  - (5) If signs of metallic debris were observed/noted in steps (2), (3), or (4), go to Section D.
