SERVICE BULLETIN

SB240F

INSPECTION OF PROPELLER BLADES FOR CRACKING

1A170E/JHA[XXXX], See Compliance: for Specific Serial

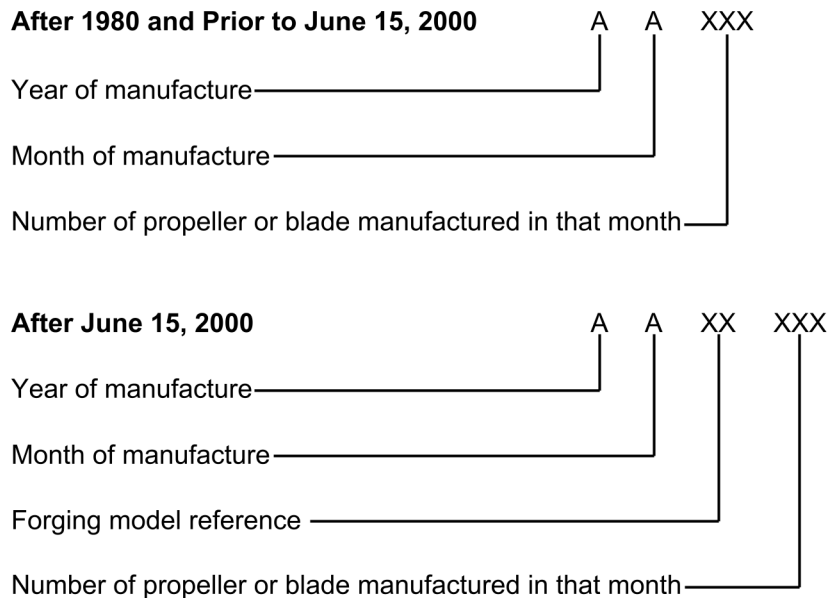
Figure 1. (Sheet 1)

As of June 15, 2000, McCauley has revised the serial number stamping system on blades and fixed pitch propellers. The first letter remains the year of manufacture, the second letter remains the month of manufacture, the next two digits will reference the forging model, and the last three digits reference the number of propeller or blades manufactured in that month.
