ALERT SERVICE BULLETIN

ASB248

RESTRICTED OPERATION, LIFE LIMIT AND REPETITIVE BLADE AIRFOIL INSPECTION REQUIREMENTS

3A32C406/82NDB-X and D3A32C409/82NDB-X

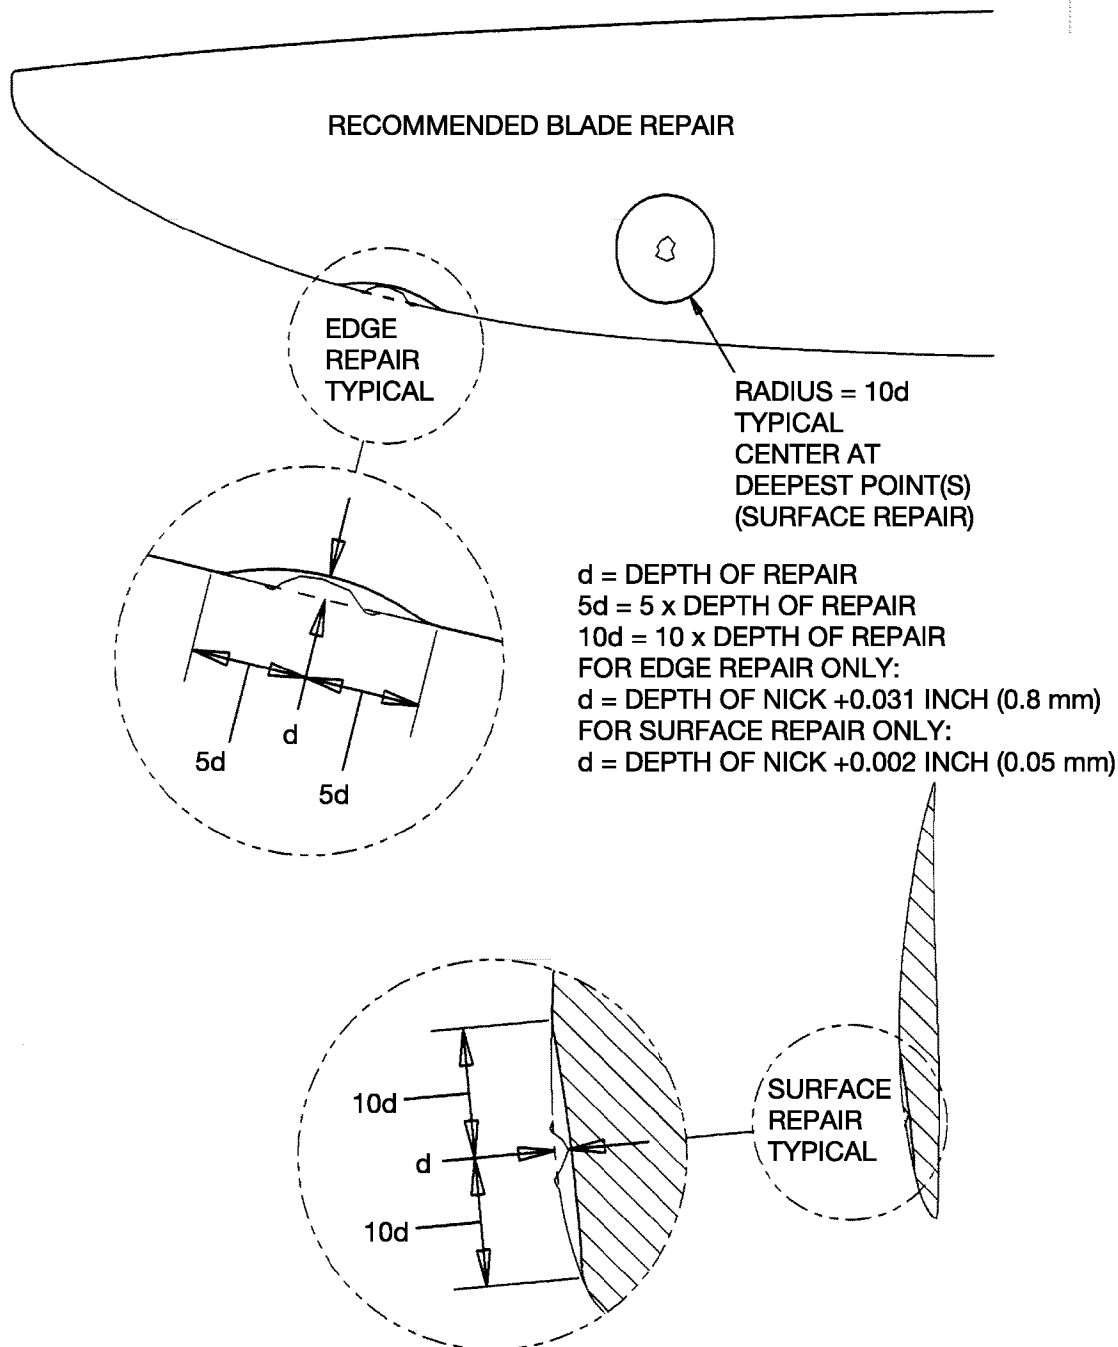
Figure 1. Blade Surface Repair (Sheet 1)

- (1) Inspect for damage that has a sharp bottom (stress riser type damage) caused by stones or other small objects striking the propeller blade as it is rotating. Refer to Step 2.C for repair procedures.

(1) Stress Riser Damage Repair

- (a) Repair stress riser damage by filing the damaged area as illustrated in Figure 1.
- (b) Do not perform additional repairs on the blade after the stress riser has been removed. Unnecessary repairs will cause premature replacement of blades at overhaul.
- (c) If damage exceeds 1/8 inch depth on the leading edge or 1/16 inch depth on the face or camber side, the propeller must be sent to a propeller repair facility for repair.

- (a) Remove metal at the damaged area starting back from and working toward the edge in such a way that the contour remains substantially the same.
 - 1 File strokes must run from blade shank to blade tip.
 - 2 Avoid abrupt changes in contour and blunt edges.
- (b) (Refer to Figure 1.) Blend the area to a length of 10 times the depth of the nick.
- (c) Work the repair surface to a smooth finish with fine grain emery cloth, crocus cloth, or 600 grit sandpaper.

- (a) Remove metal at damaged area using a hand held rotary grinder with a sanding bob with 120 grit or less, or by hand using coarse grain emery cloth. Do not use a file in this area.
- (b) (Refer to Figure 1.) Grind the blade with light pressure in a circular motion until the damage is totally removed.
 - 1 The repaired area must have a diameter equal to 20 times the depth of the damage as illustrated in Figure 1.
