SERVICE LETTER

SL2026-1

PROPELLER COUNTERWEIGHT ATTACH BOLT TORQUE VERIFICATION

To verify the correct torque of the propeller counterweight attach bolts.

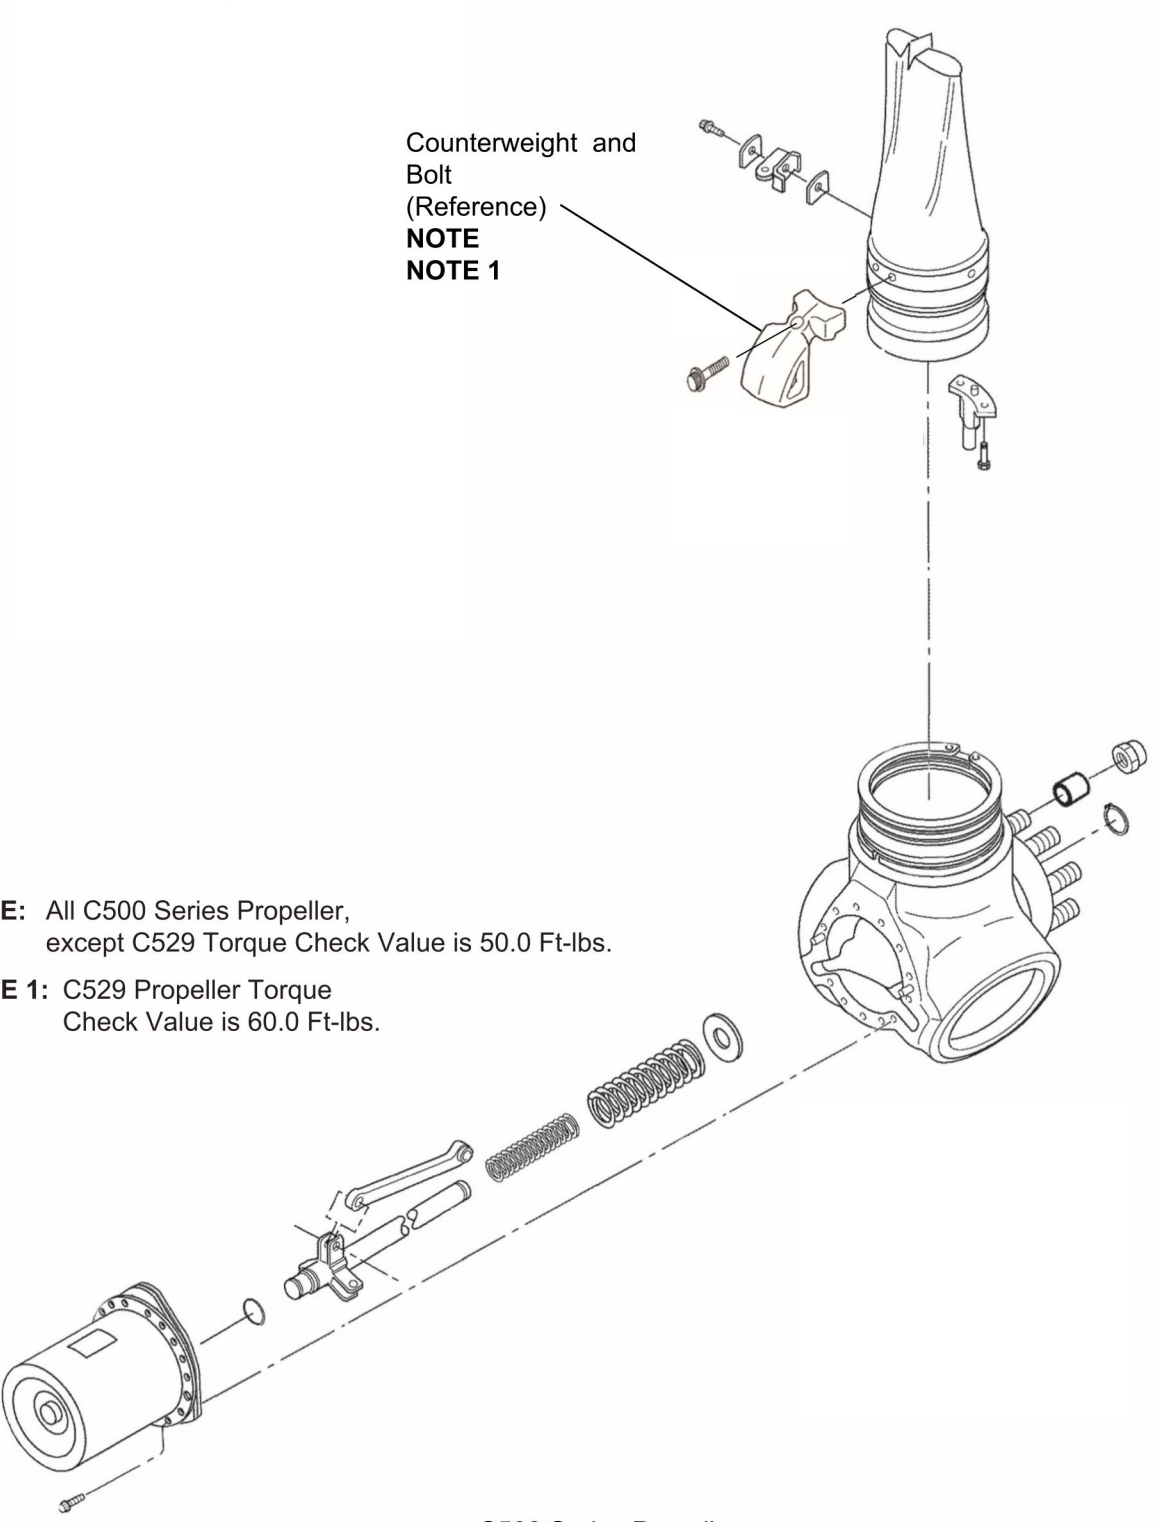
Figure 1. (Sheet 1)

C500 Series Propellers

A. (Refer to Figure 1, Sheets 1 thru 5.) Verify the counterweight attach bolt torque of each propeller as follows:

- (1) Set a torque wrench to the necessary value 'Torque Check Value' for the model of propeller (Table II).

- (2) Using the torque wrench, check each counterweight attach bolt.
 - (a) If one or more bolt(s) is below the 'Torque Check Value', remove the propeller from the aircraft and return to a McCauley Authorized Repair Facility for completion of Step 4. (Refer to the applicable Aircraft Maintenance Manual.)
 - (b) If all bolts are above the 'Torque Check Value', go to step 3. B.

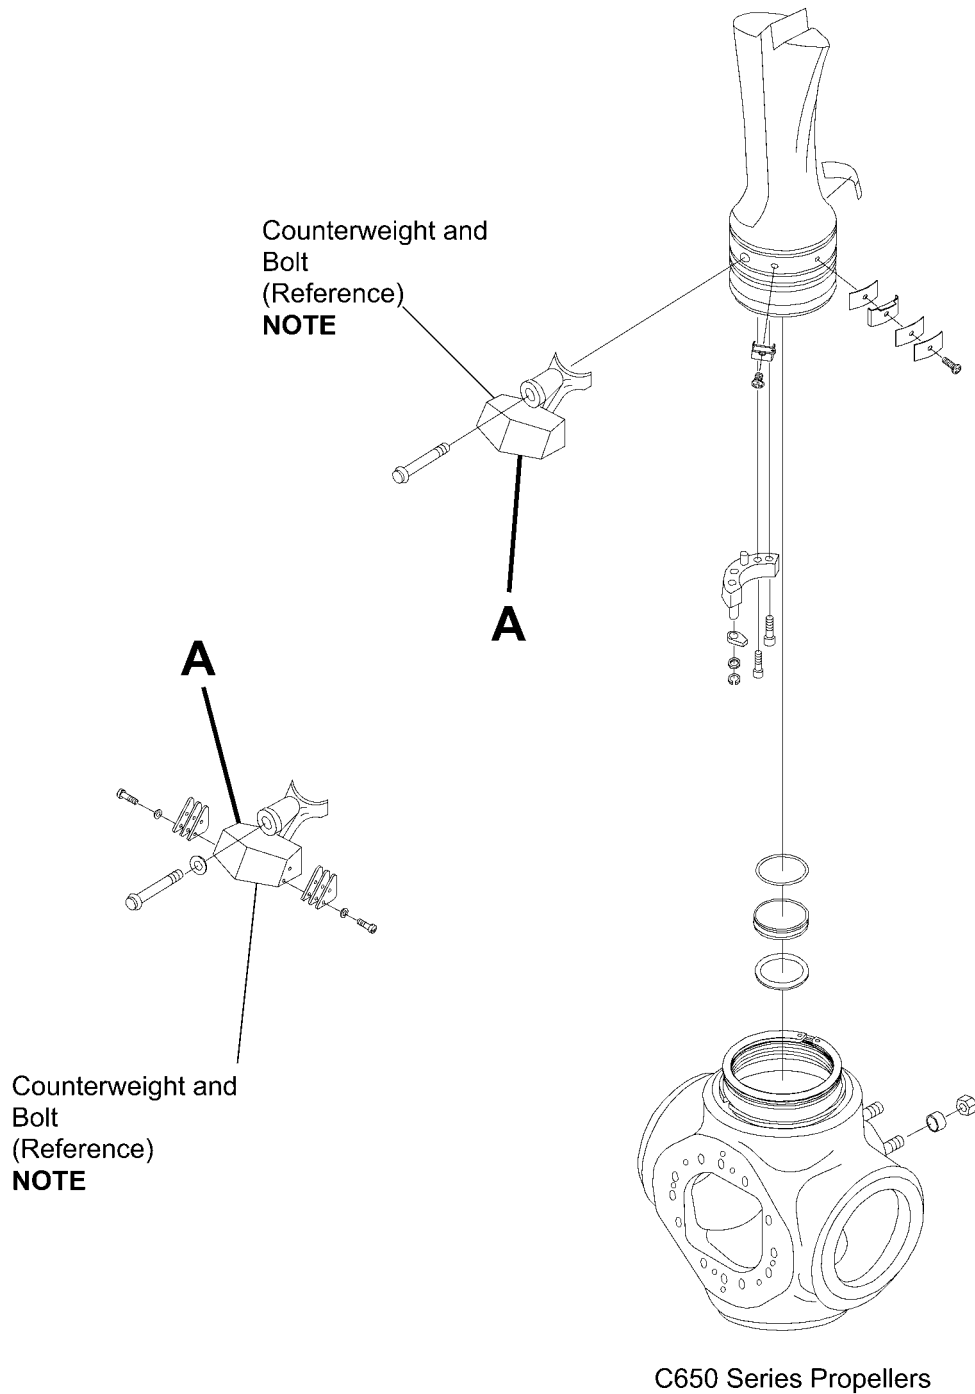
Figure 1. (Sheet 2)

C650 Series Propellers

NOTE: All C600 and C650 Series Propeller Torque Check Value is 60.0 Ft-lbs.

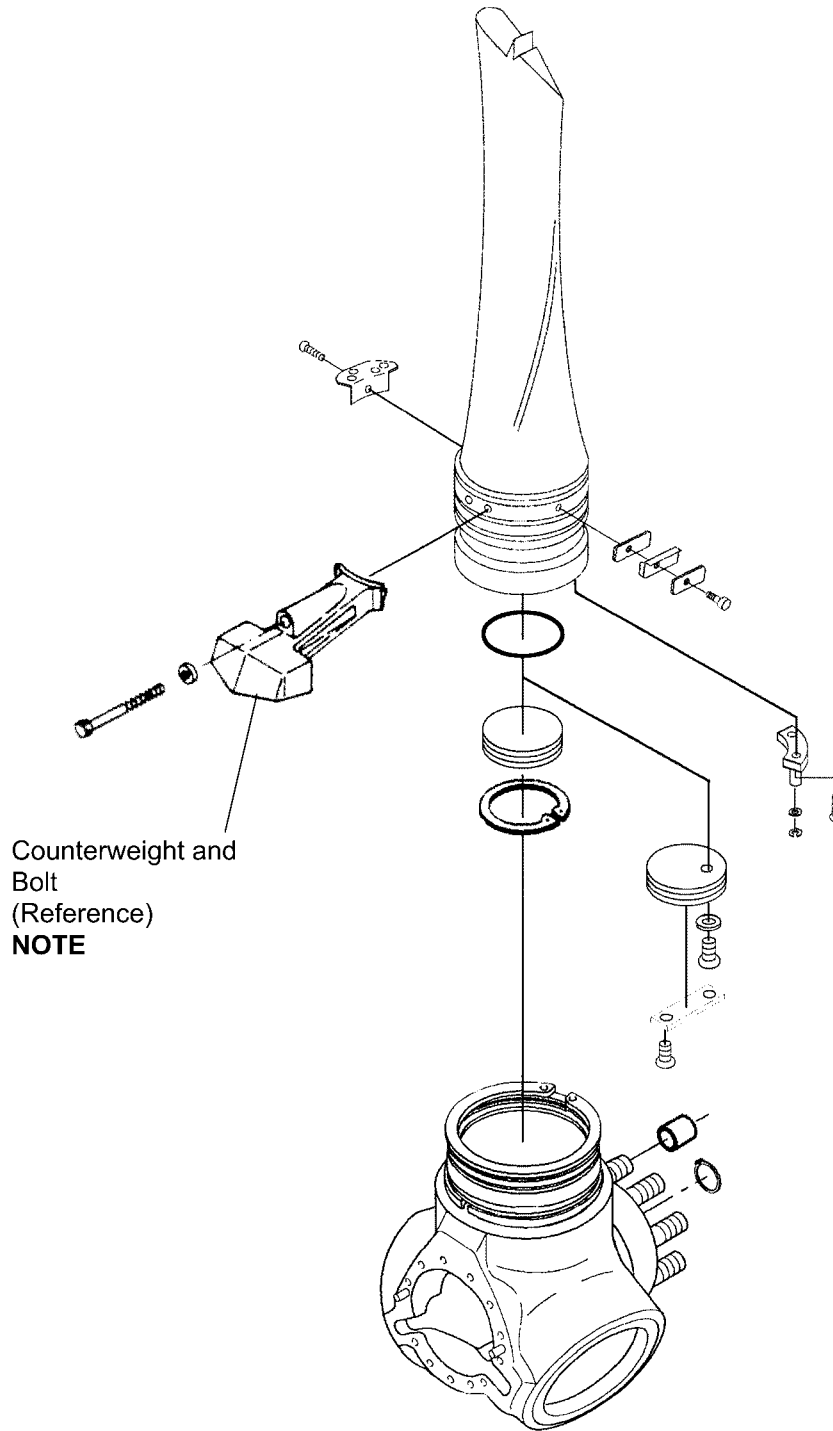
Figure 1. (Sheet 3)

C700 Series Propellers

NOTE: All C700 Series Propeller
Torque Check Value is 60.0 Ft-lbs.

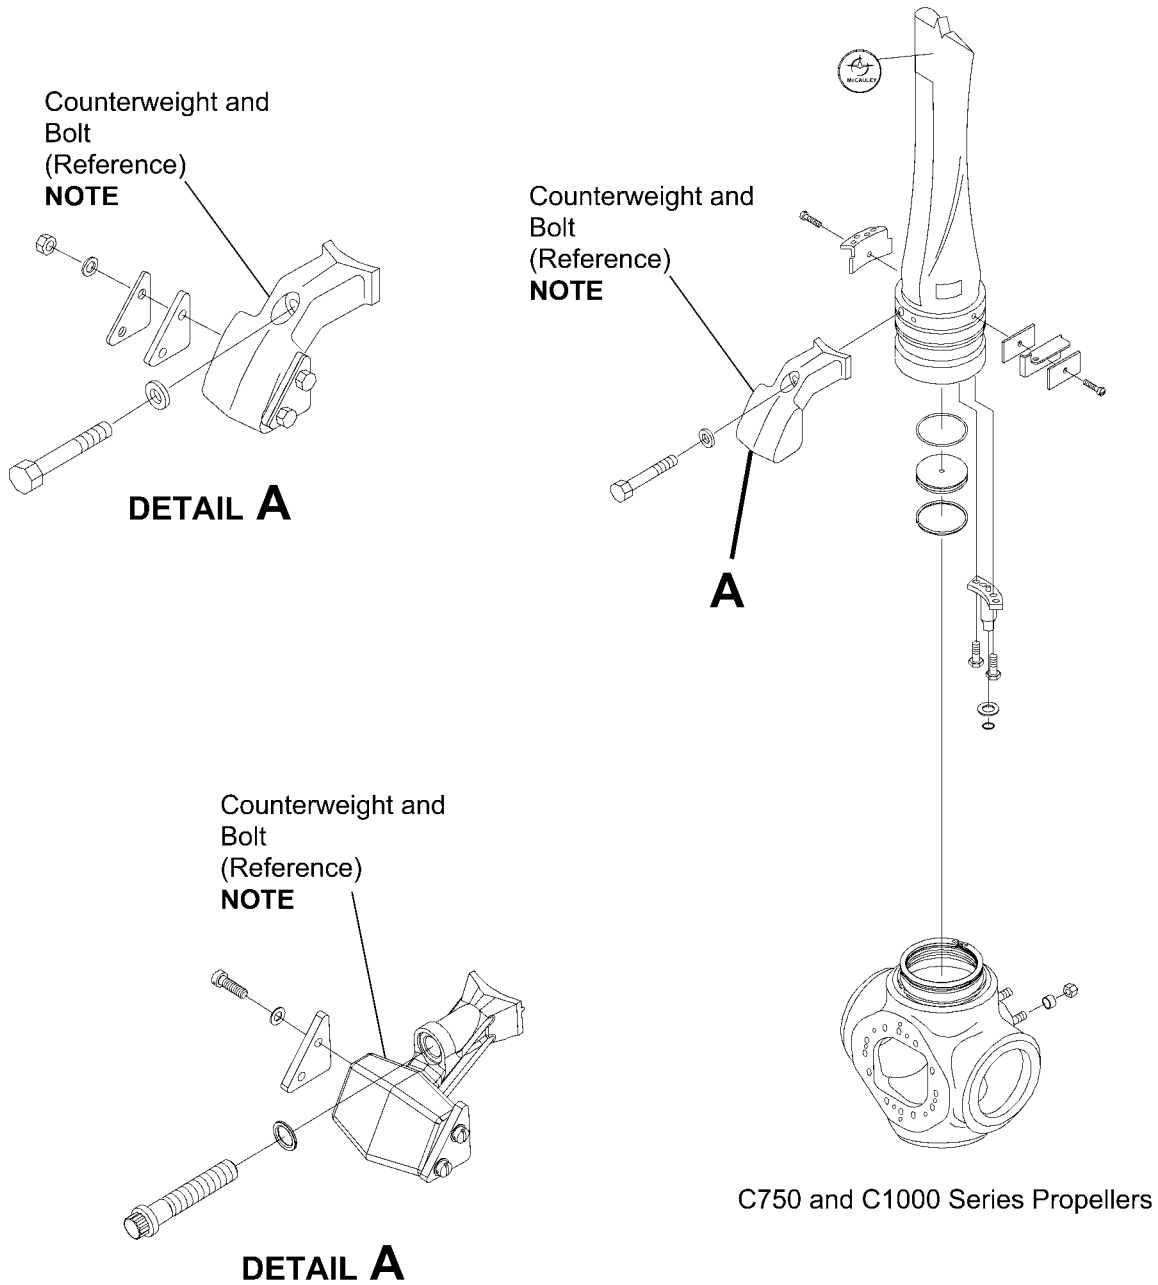
Figure 1. (Sheet 4)

NOTE: All C750 and C1000 Series Propeller Torque Check Value is 60.0 Ft-lbs.

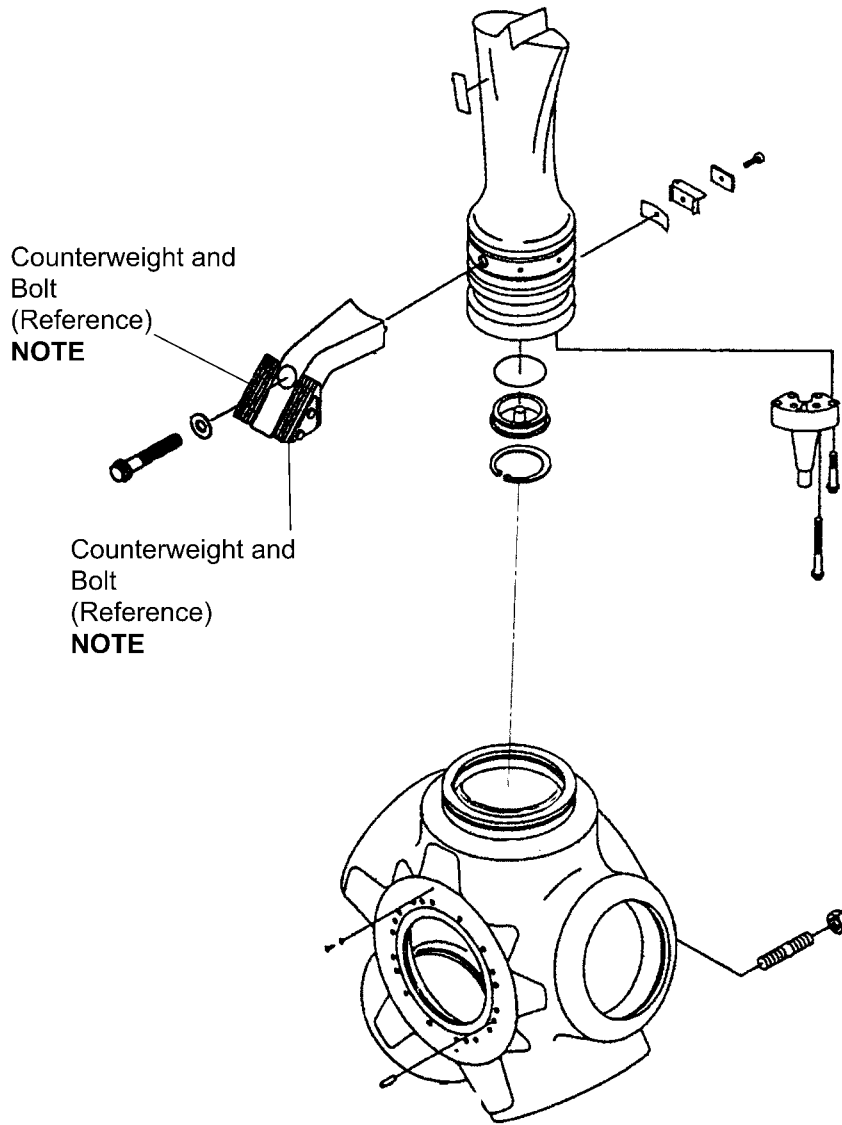
Figure 1. (Sheet 5)

C1100 Series Propellers

NOTE: All C1100 Series Propeller Torque Check Value is 60.0 Ft-lbs.
