# SERVICE LETTER

SL2026-2A

PROPELLER COUNTERWEIGHT ATTACH BOLT TORQUE VERIFICATION

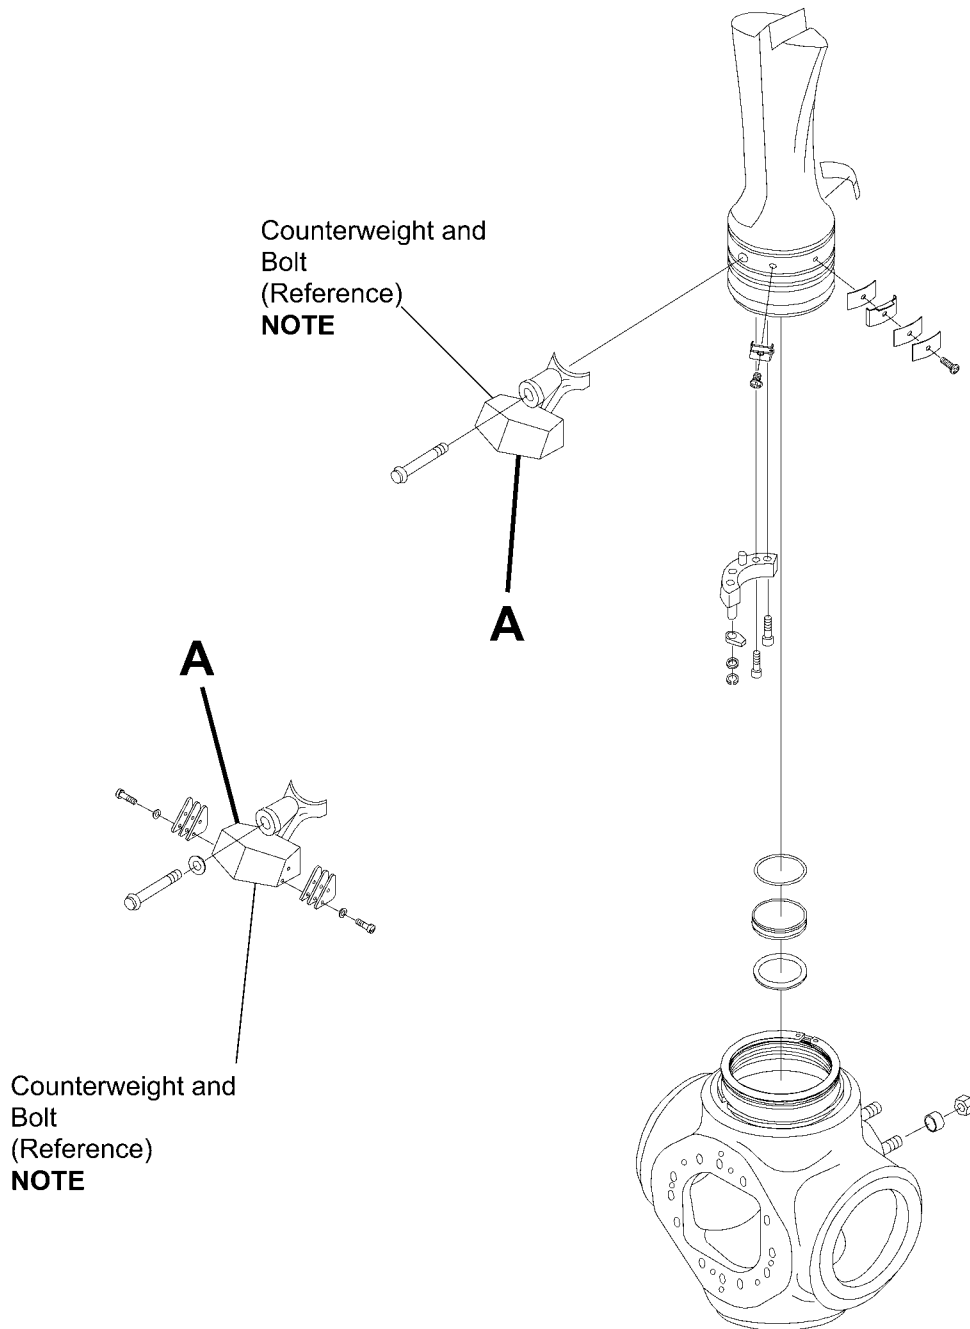
Figure 1. (Sheet 1)

**NOTE:** All C600 Series Propeller Torque Check Value is 60.0 Ft-lbs.

1. Remove the spinner from the propeller to gain access to the propeller counterweights. (Refer to the applicable Aircraft Maintenance Manual.)
2. **Field Work Instructions:**
  - A. (Refer to Figure 1, Sheet 1.) Verify the counterweight attach bolt torque of each propeller as follows:
    - (1) Set a torque wrench to the necessary value 'Torque Check Value' for the model of propeller (Table I).

- (2) Using the torque wrench, check each counterweight attach bolt.
  - (a) If one or more bolt(s) is below the "Torque Check Value", verify if the propeller has accumulated any hours of engine run or flight time.

- (c) If all bolts are above the 'Torque Check Value', go to step 2. B.
- B. Torque the counterweight attach bolts of each propeller as follows:
  - (1) Set a torque wrench to the 'Required Torque Value' (Refer to Table I).
